FIELD OVERSIGHT SUMMARY REPORT
ACS NPL SITE
GRIFFITH, INDIANA
February 6, 1997 - March 28, 1997

**USEPA/ARCS V
BVSPC Field Oversight Summary**

Reporting Period: February 6, 1997 - March 28, 1997

Site Name/Location: ACS, Griffith, IN

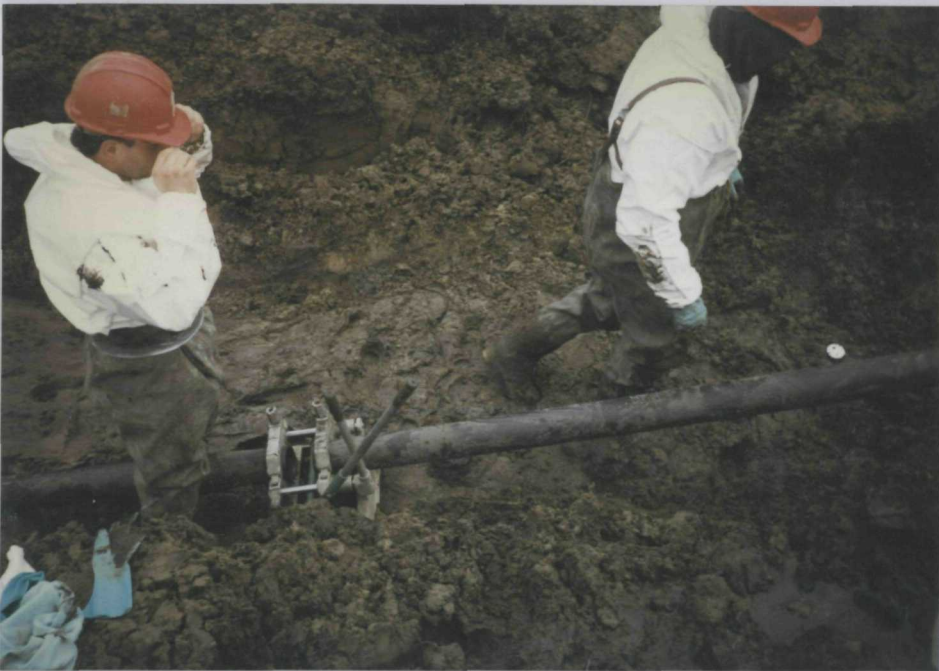
Site: American Chemical Services, Inc. RD/ERA
 Proj. #: 71670.600
 Roll: 2 Photo #: 79
 Date: 02-18-97 Time: 1405
 Photographer: Ashok Rupani
 Description: Facing north-east. Youngs fusing the HDPE pipe together after the pipe was snapped by the excavator.

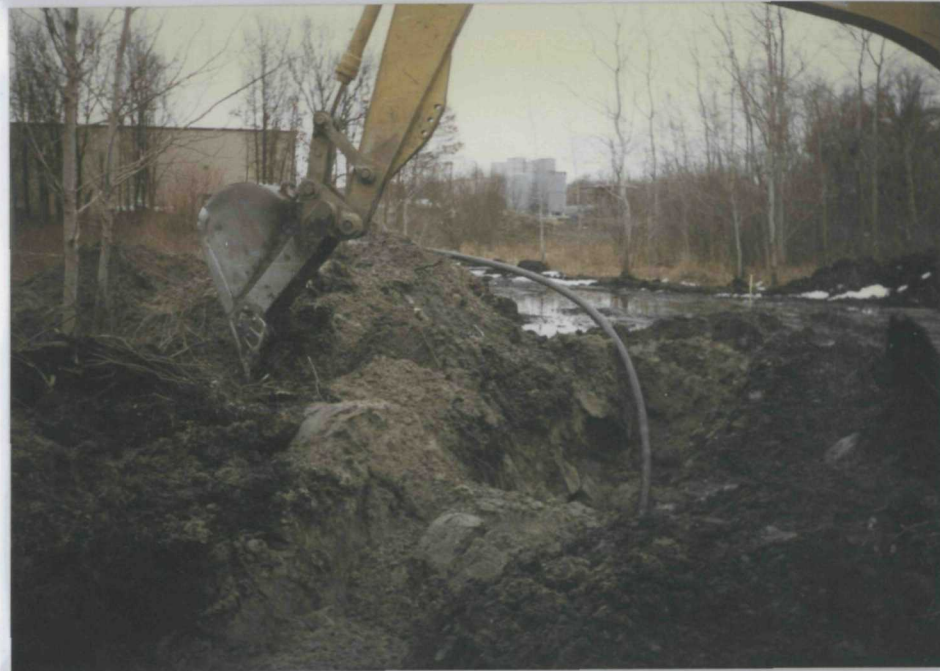
Site: American Chemical Services, Inc. RD/ERA
 Proj. #: 71670.600
 Roll: 2 Photo #: 80
 Date: 02-18-97 Time: 1455
 Photographer: Ashok Rupani
 Description: Facing south-east. Youngs completes the installation of the northern leg of the effluent discharge system.

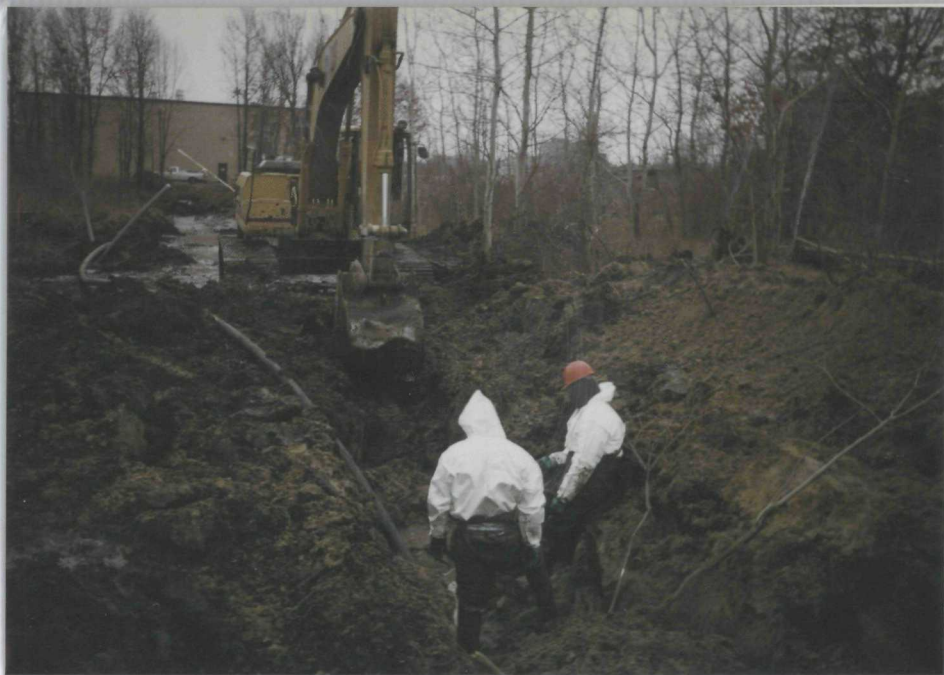
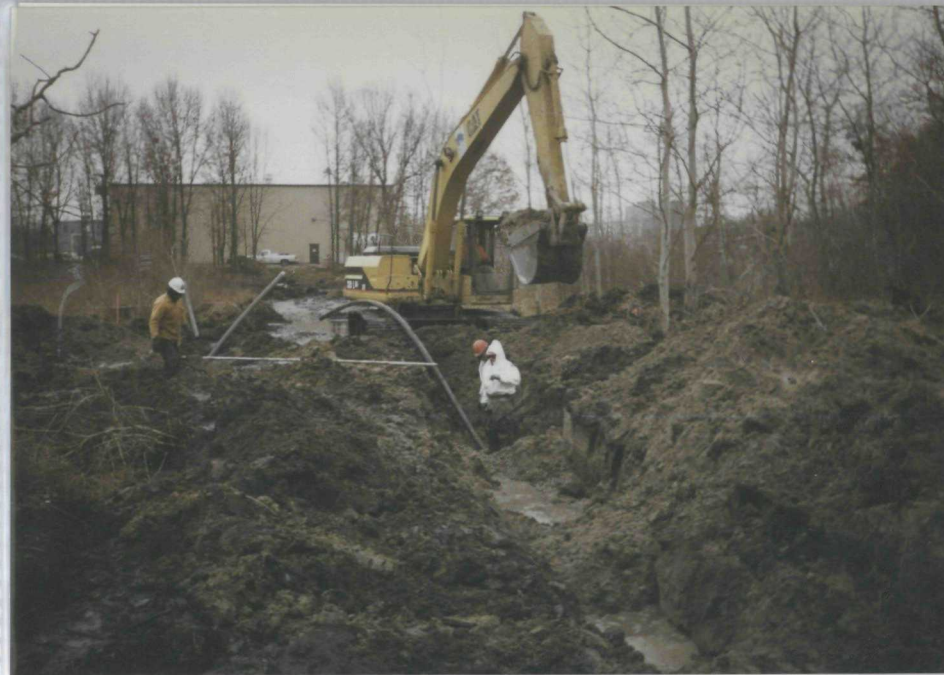
Site: American Chemical Services, Inc. RD/ERA
 Proj. #: 71670.600
 Roll: 2 Photo #: 81
 Date: 02-19-97 Time: 0900
 Photographer: Ashok Rupani
 Description: Facing east. Youngs completes the installation of the central leg of the effluent discharge system.

Site: American Chemical Services, Inc. RD/ERA
 Proj. #: 71670.600
 Roll: 2 Photo #: 82
 Date: 02-18-97 Time: 0900
 Photographer: Ashok Rupani
 Description: Facing east. Youngs completes the installation of the central leg of the effluent discharge system.

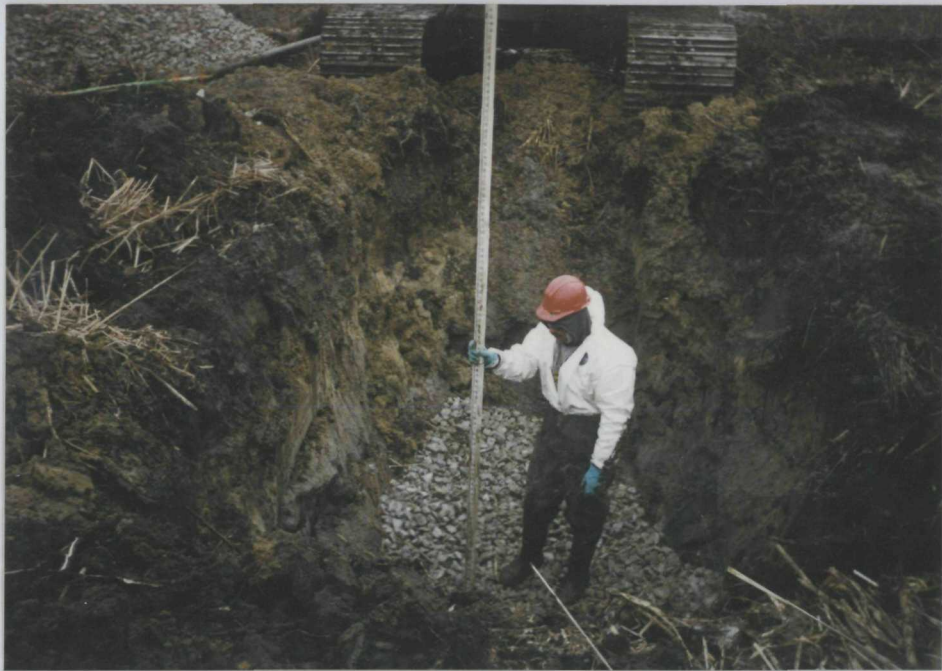
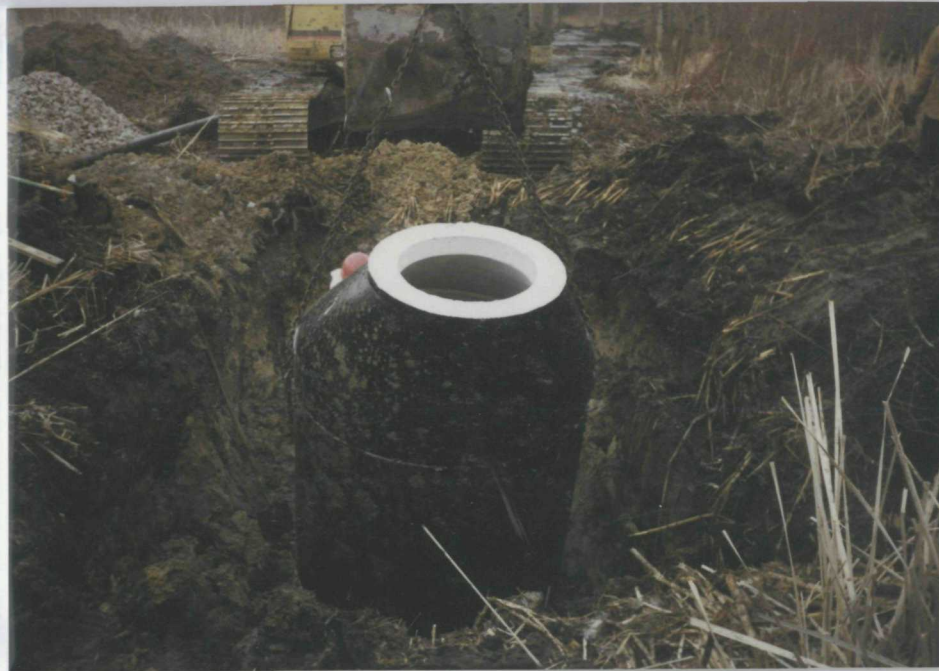
Description: Facing north-east. Youngs setting the manhole for the southern leg of the effluent discharge system.

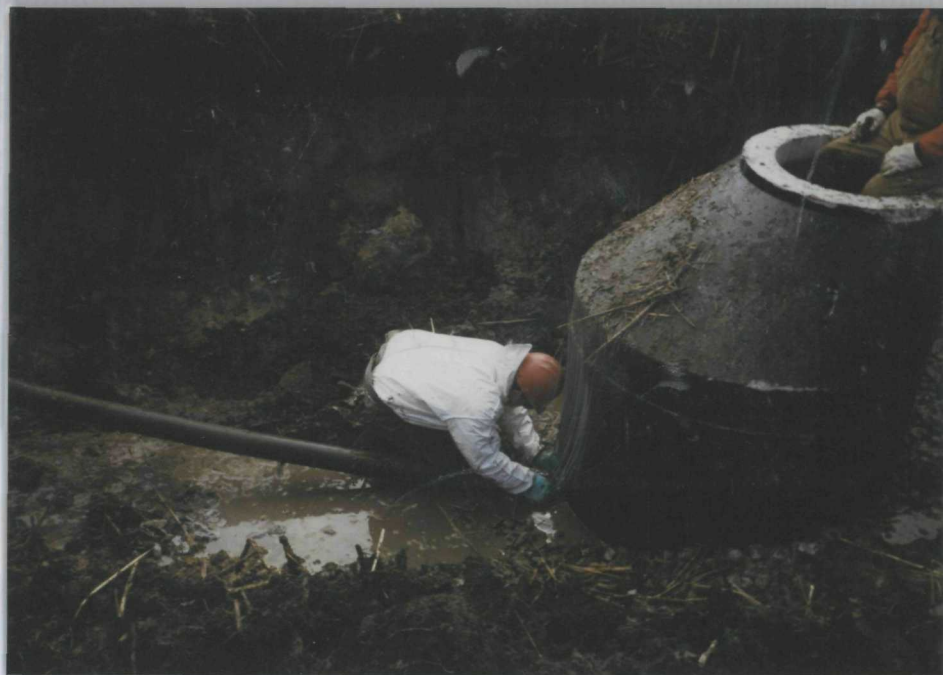
Site: American Chemical Services, Inc. RD/ERA
 Proj. #: 71670.600
 Roll: 2 Photo #: 85
 Date: 02-19-97 Time: 1115
 Photographer: Ashok Rupani
 Description: Facing south-east. Youngs installing a 4-inch HDPE pipe for the southern leg of the effluent discharge system.

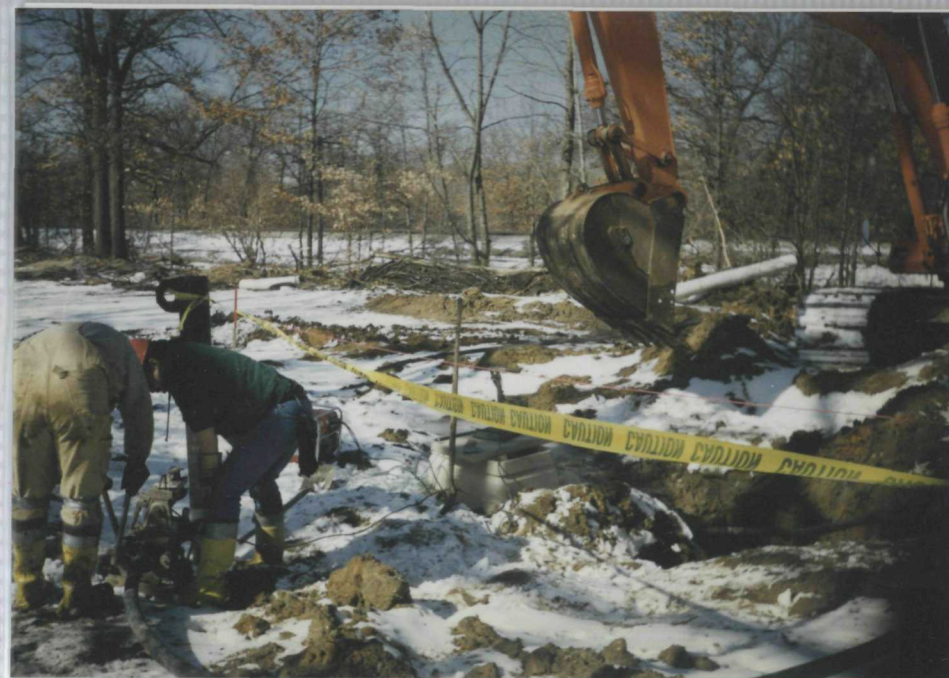
Site: American Chemical Services, Inc. RD/ERA
 Proj. #: 71670.600
 Roll: 2 Photo #: 86
 Date: 02-24-97 Time: 1400
 Photographer: Ashok Rupani
 Description: Facing north-west. Youngs connecting the PGCS conveyance piping to the northern PGCS sump.

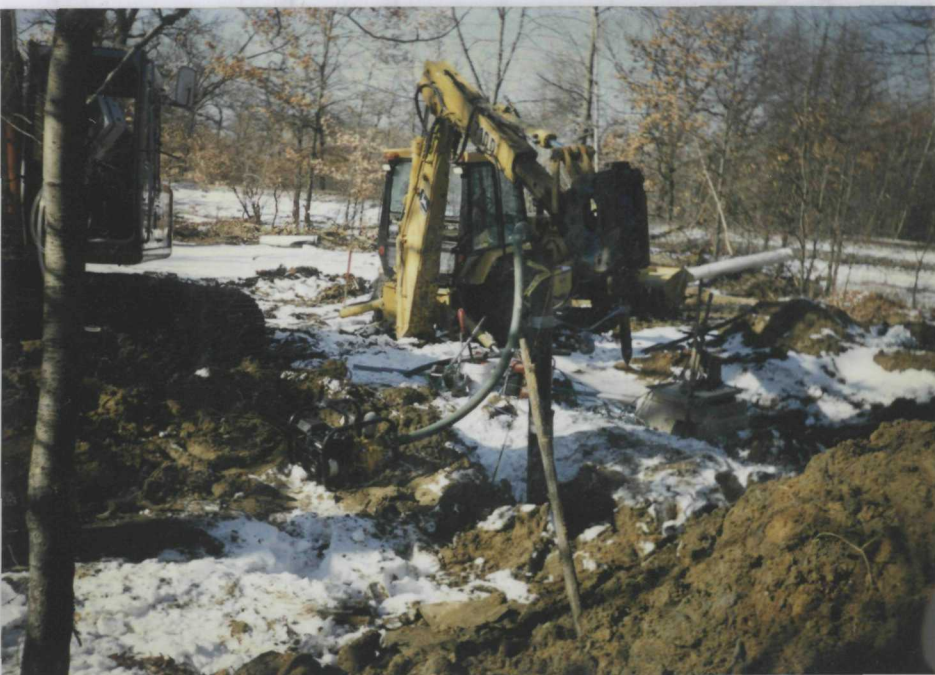
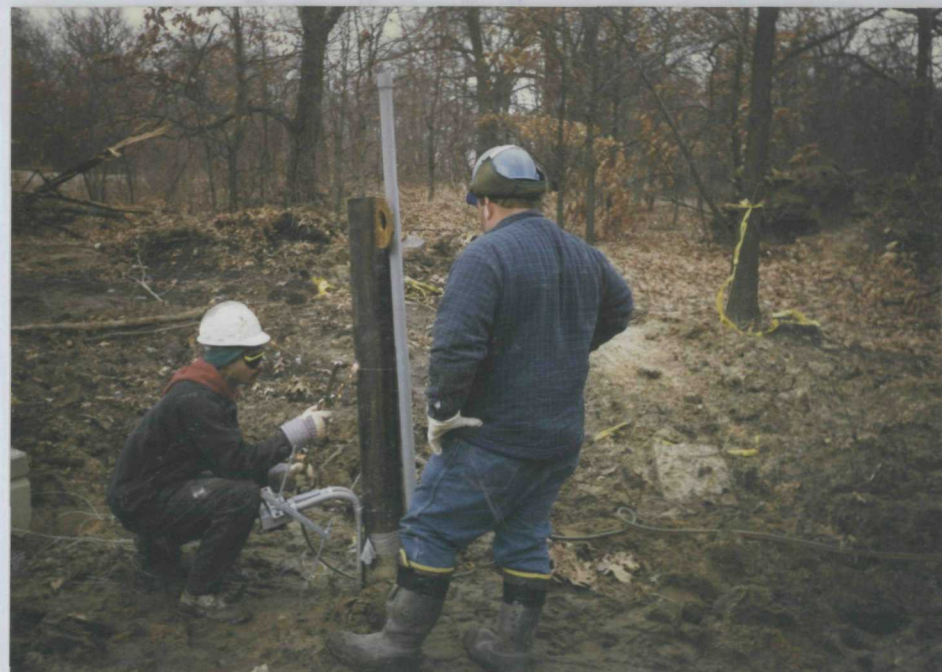
Description: Facing north-west. Youngs pumping groundwater from the northern PGCS sump to temporarily create dry conditions around the sump. The dry conditions facilitated the pipe installation activities.

Description: Facing north-west. HTI installing well cap at the northern PGCS sump.

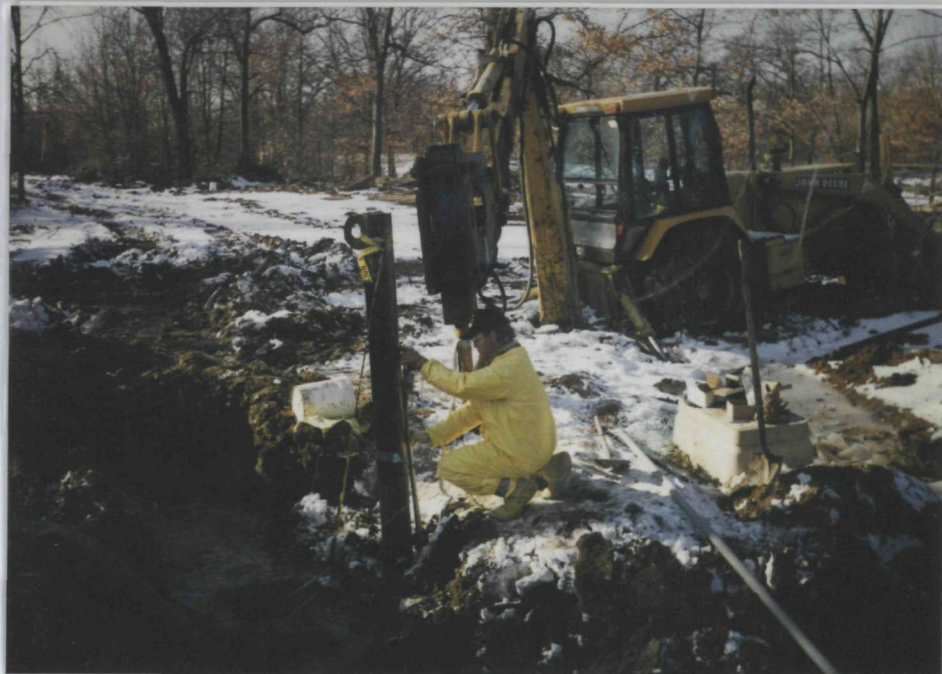
Site: American Chemical Services, Inc. RD/ERA
 Proj. #: 71670.600
 Roll: 2 Photo #: 89
 Date: 02-24-97 Time: 1505
 Photographer: Ashok Rupani
 Description: Facing north-west. Youngs conducting electrical work at the northern PGCS sump.

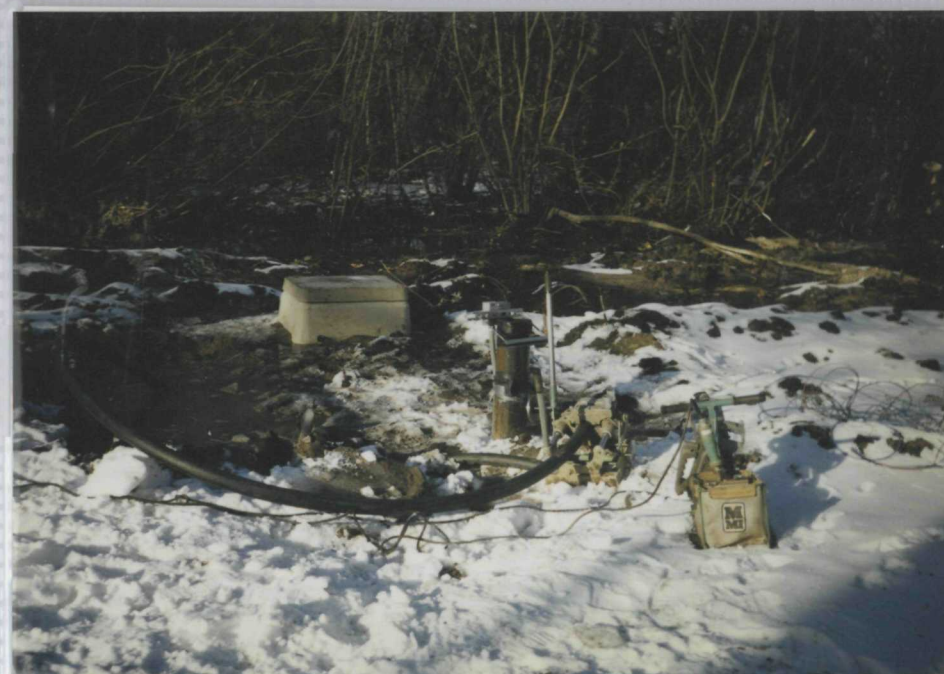
Site: American Chemical Services, Inc. RD/ERA
 Proj. #: 71670.600
 Roll: 2 Photo #: 90
 Date: 02-24-97 Time: 1515
 Photographer: Ashok Rupani
 Description: Facing west. Youngs connecting the PGCS conveyance piping to the central PGCS sump.

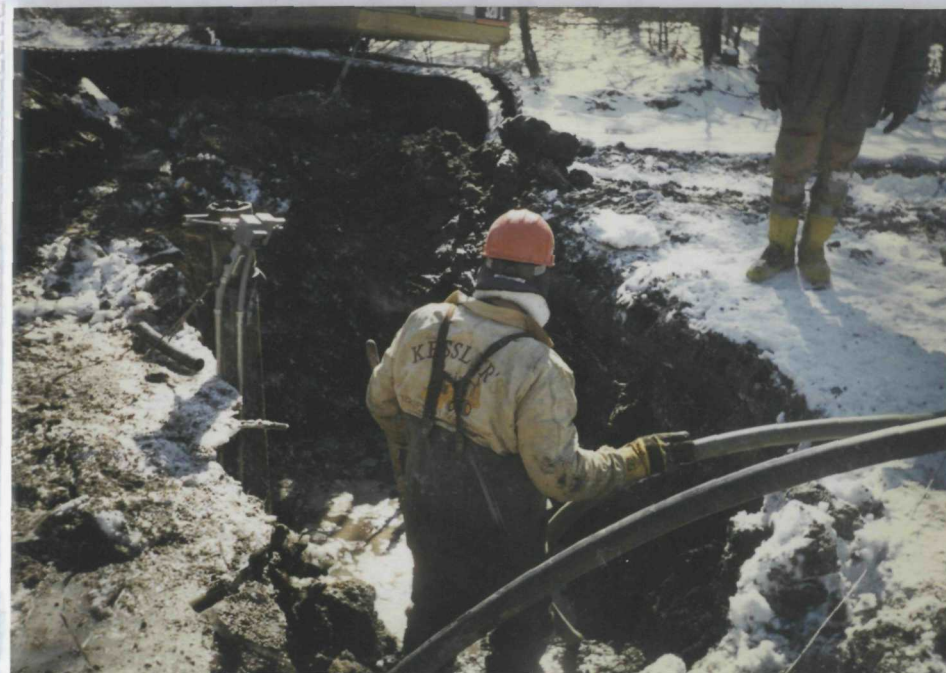
Site: American Chemical Services, Inc. RD/ERA
 Proj. #: 71670.600
 Roll: 2 Photo #: 91
 Date: 02-24-97 Time: 1545
 Photographer: Ashok Rupani
 Description: Facing south. Youngs connecting the PGCS conveyance piping to the southern PGCS sump.

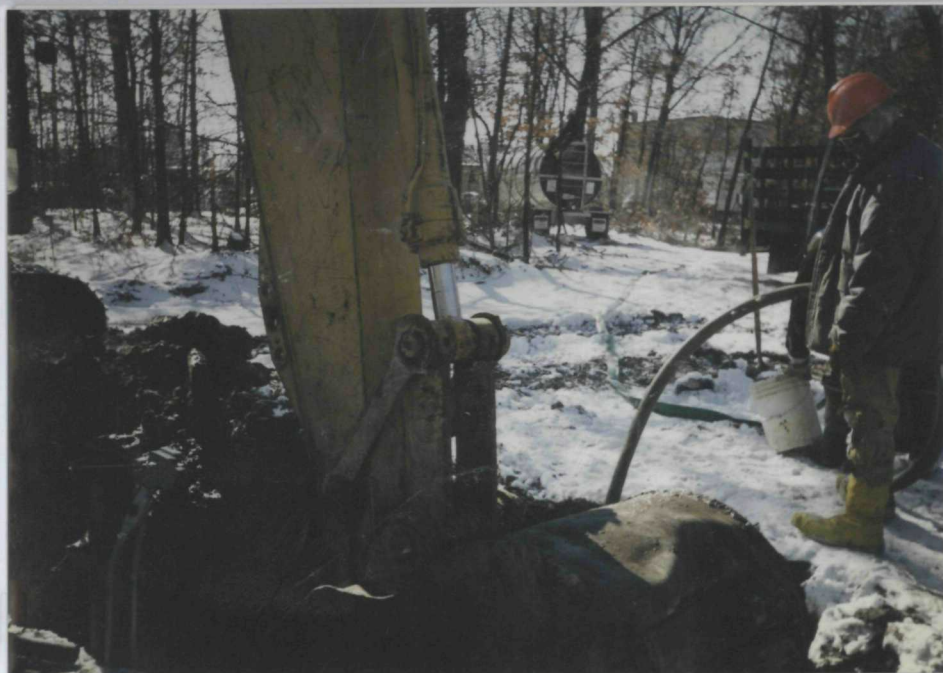
Site: American Chemical Services, Inc. RD/ERA
 Proj. #: 71670.600
 Roll: 2 Photo #: 92
 Date: 02-25-97 Time: 1035
 Photographer: Ashok Rupani
 Description: Facing east. Youngs excavating around the central PGCS sump in order to repair the sump. The damage had occurred earlier when Youngs was trying to hook up the PGCS conveyance piping to the sump.

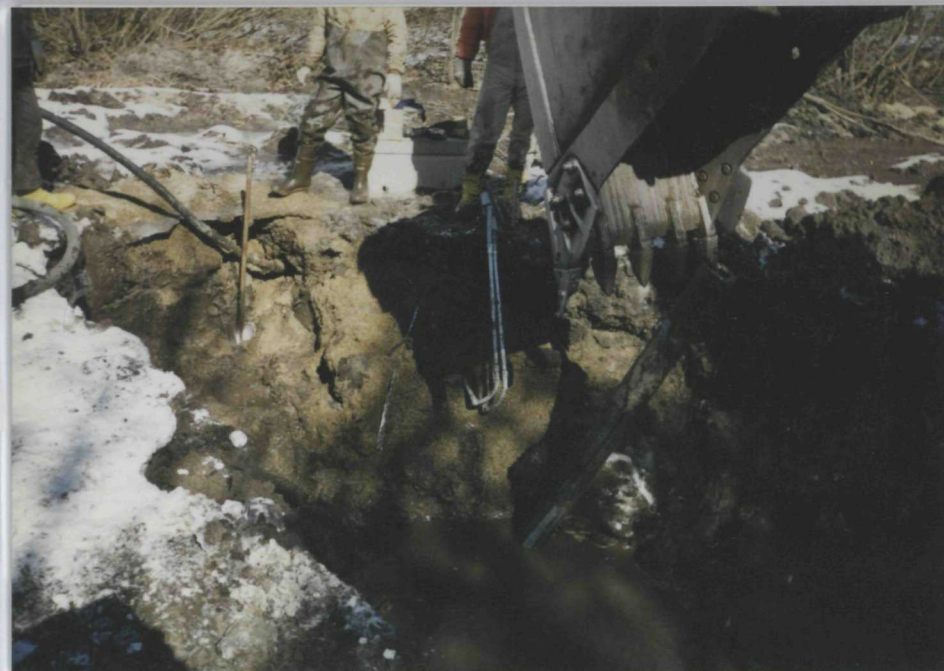
Description: Facing east. In order to facilitate repair work described in Photo #92, Youngs used a Vac Truck (seen in background) to de-water the area. The groundwater pumped during this operation was temporarily stored in the Baker storage tanks.

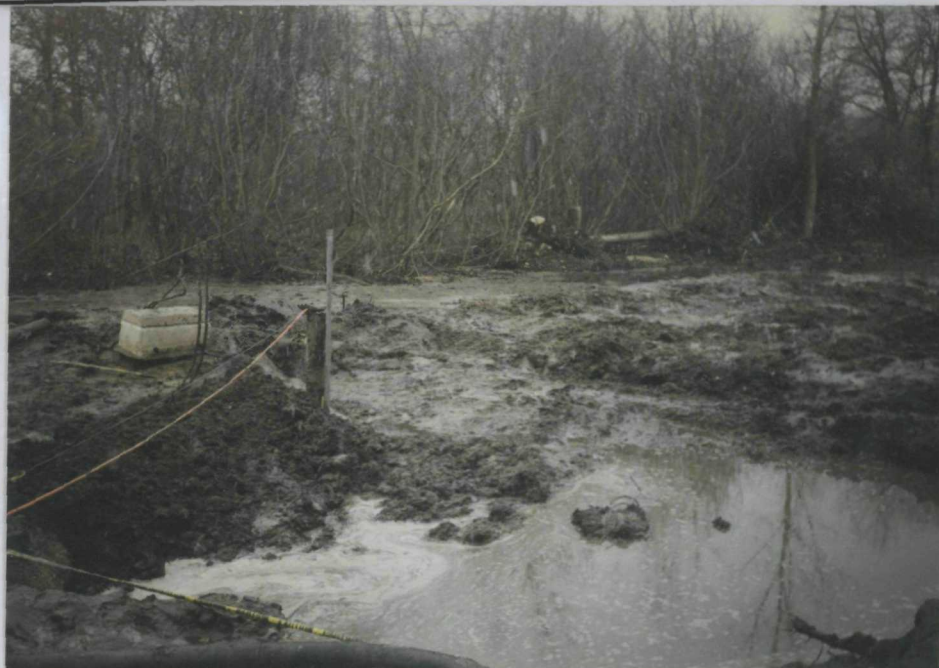
Description: Facing west. De-watering and repair activities at the central PGCS sump.

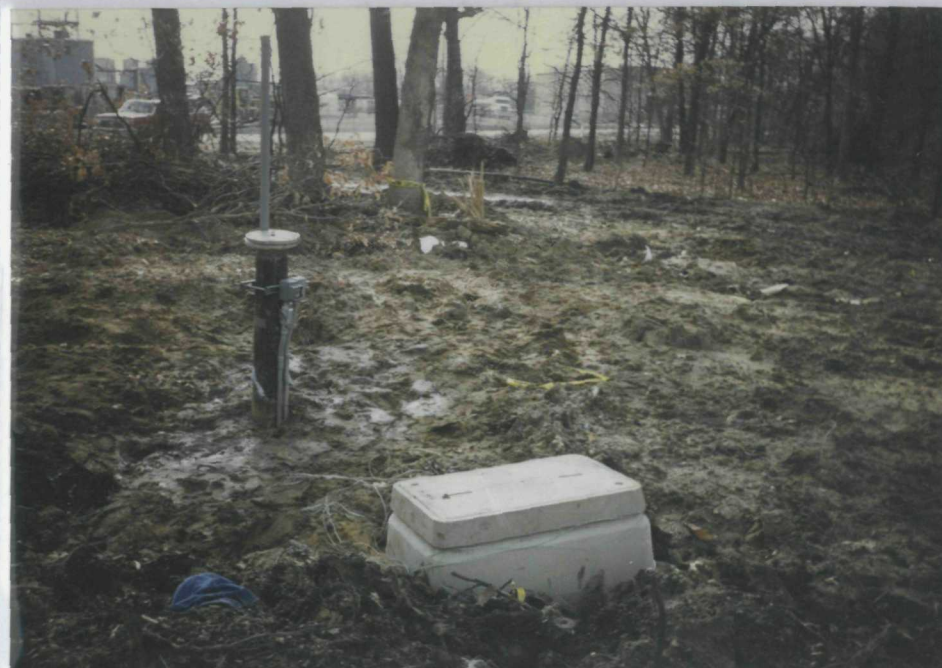
Description: Facing east. Youngs completes the repair work at the central PGCS sump with HTI's help.

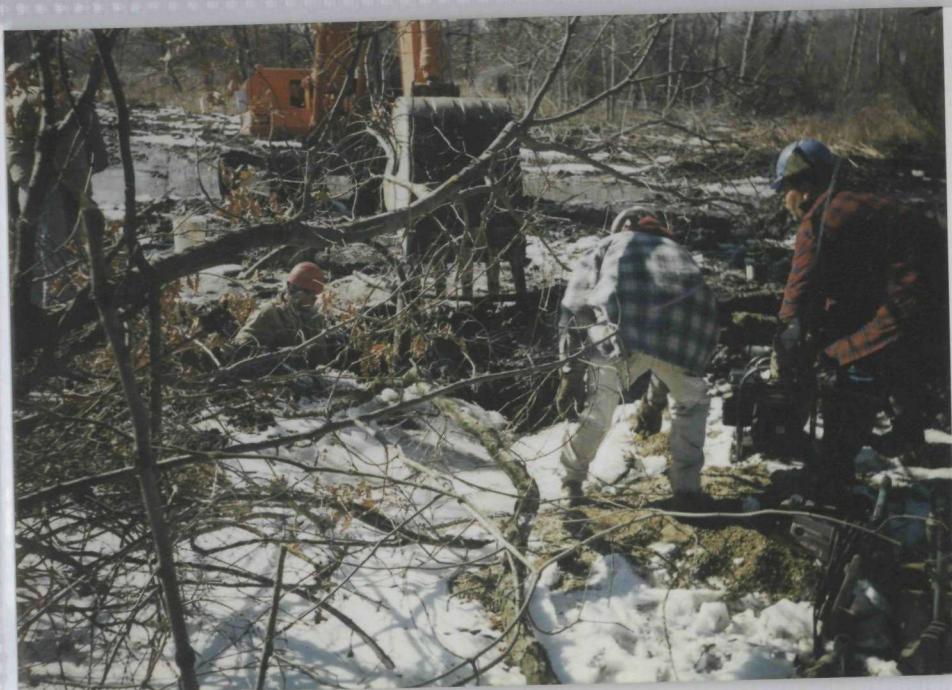
Description: Facing south. HTI completes the installation of well cap at the northern PGCS sump.

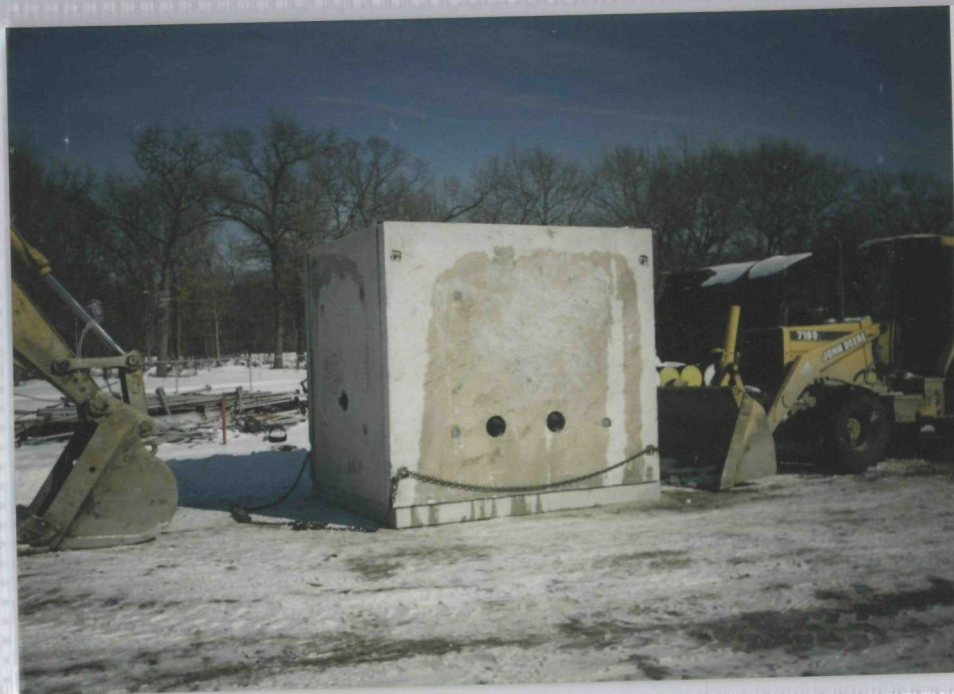
Site: American Chemical Services, Inc. RD/ERA
 Proj. #: 71670.600
 Roll: 2 Photo #: 98
 Date: 02-17-97 Time: 1125
 Photographer: Ashok Rupani
 Description: Facing north. The concrete valve vault for the effluent discharge system.

The original design of the PGCS effluent discharge system had called for installation of a valve vault from where the three discharge pipes would begin their run towards the wetlands. The intended location of this valve vault was approximately 200 feet west of the PGCS extraction trench across from station 28+00. Due to heavy weight (approximately 20 tons) of the concrete vault and extremely wet and muddy conditions in the installation area, Youngs was unsuccessful in keeping the excavation open long enough to complete the installation, in spite of continuously pumping/de-watering the excavation and using the steel sheet piles. The steel sheet piles were pushed/driven with the help of back-hoe bucket. Youngs halted the installation activities on March 4, 1997, and began working with Montgomery Watson's design engineers to come up with other options which could be utilized.

On March 10, 1997, Youngs and Montgomery Watson decided to do away with the vault and install only the valve assembly approximately four (4) to five (5) feet bgs. To avoid problems due to the wet and muddy conditions, the location of the valve assembly was moved further east as described earlier. Youngs began installation of the valve assembly on March 11, 1997. The three discharge pipes had to be extended further east to reach new valve assembly location.

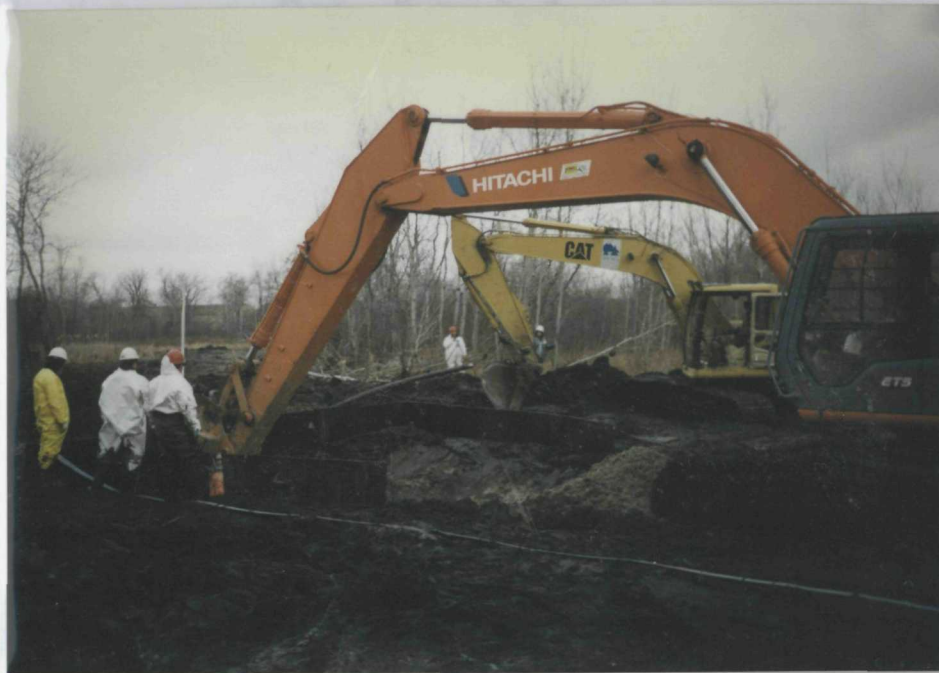
Site: American Chemical Services, Inc. RD/ERA
 Proj. #: 71670.600
 Roll: 3 Photo #: 99
 Date: 03-03-97 Time: 1400
 Photographer: Ashok Rupani
 Description: Facing north. Youngs attempting to lift the concrete valve vault with the help of two back-hoes.

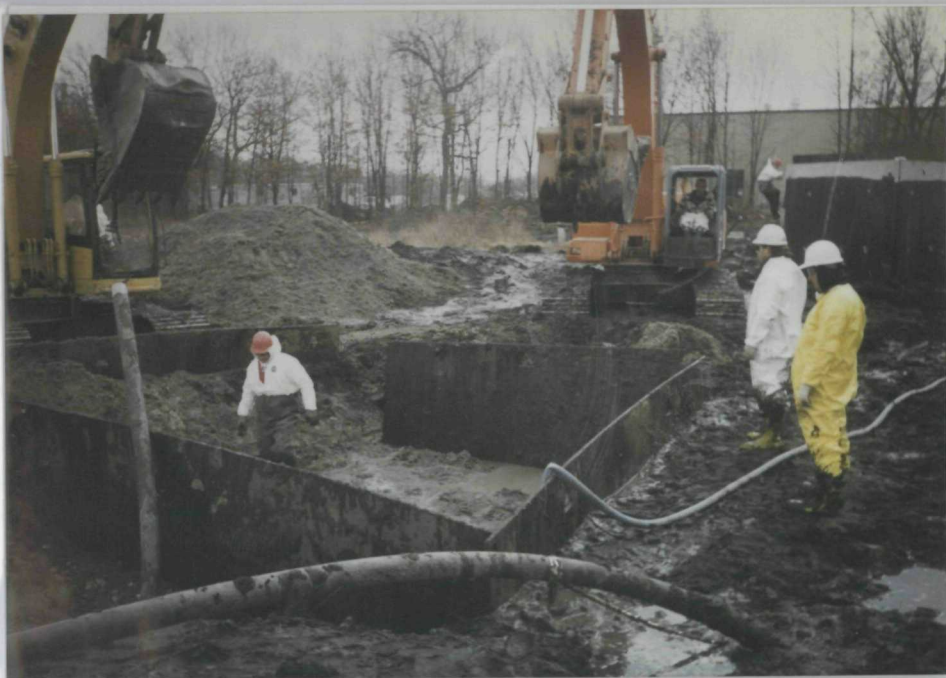
Site: American Chemical Services, Inc. RD/ERA
 Proj. #: 71670.600
 Roll: 3 Photo #: 100
 Date: 03-04-97 Time: 0945
 Photographer: Ashok Rupani
 Description: Facing north-west. Youngs installing steel sheeting to facilitate valve vault placement under extremely muddy conditions.

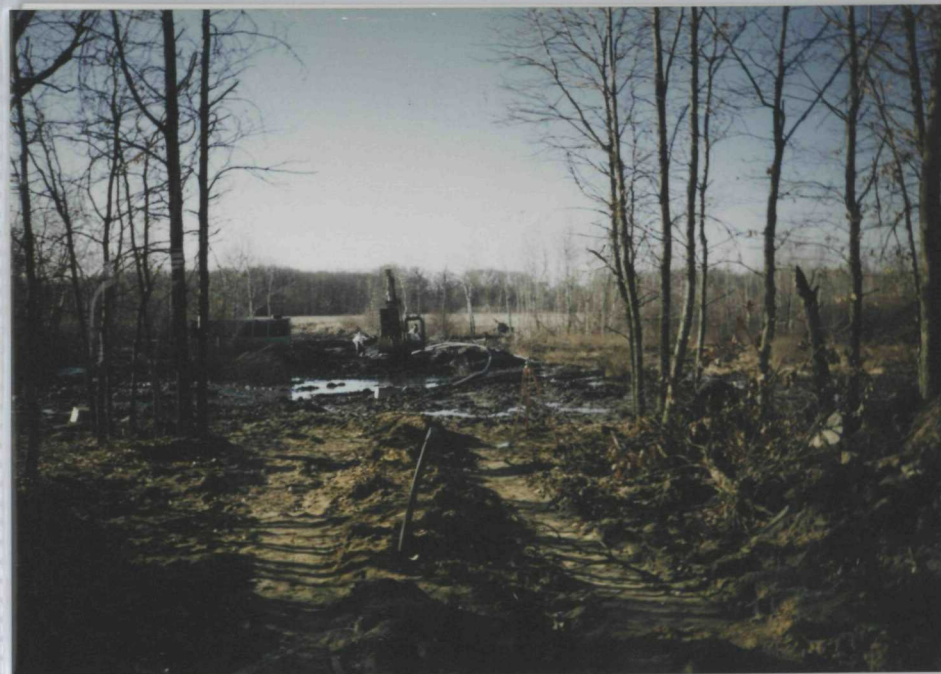
Site: American Chemical Services, Inc. RD/ERA
 Proj. #: 71670.600
 Roll: 3 Photo #: 101
 Date: 03-04-97 Time: 0945
 Photographer: Ashok Rupani
 Description: Facing north-east. Youngs installing steel sheeting to facilitate valve vault placement under extremely muddy conditions.

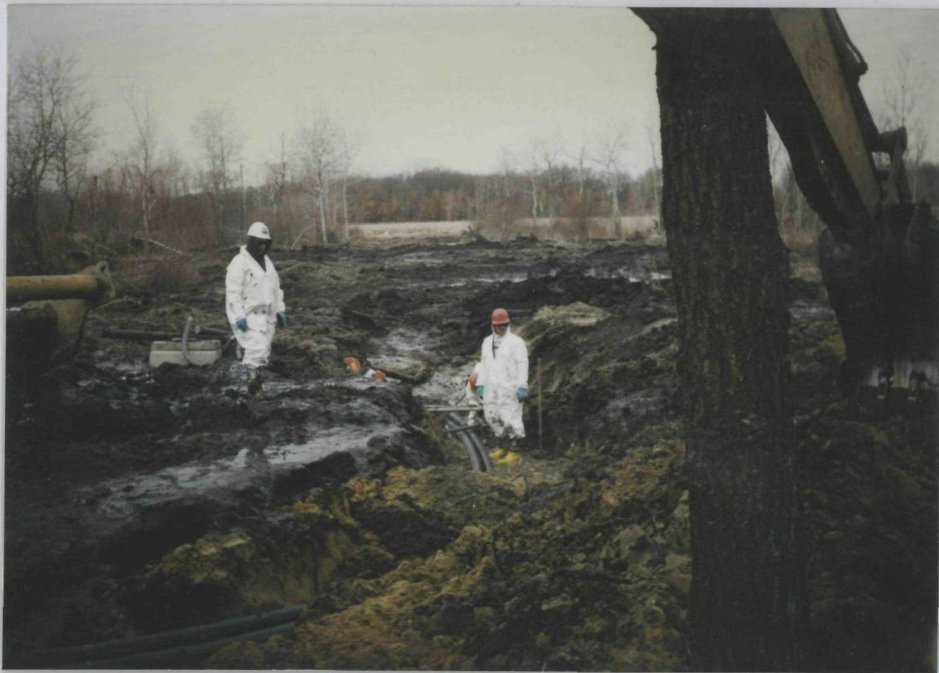
Site: American Chemical Services, Inc. RD/ERA
 Proj. #: 71670.600
 Roll: 3 Photo #: 102
 Date: 03-11-97 Time: 1610
 Photographer: Ashok Rupani
 Description: Facing west. Youngs extending the pipes from the three discharge lines further east. The three pipes were extended in two separate trenches.

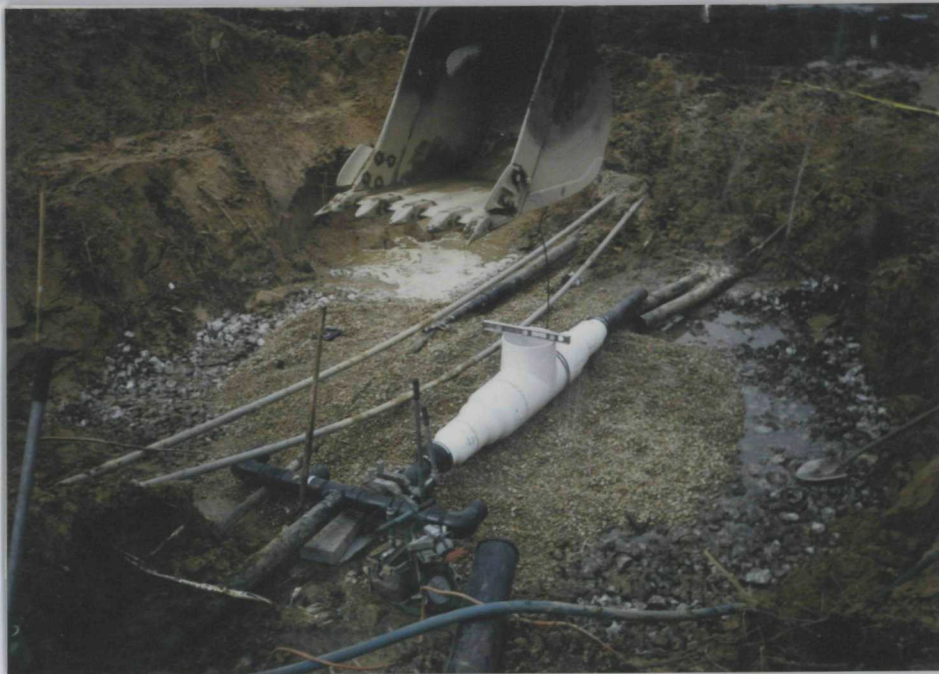
Description: Facing north-east. After the three discharge lines were extended further east to the proposed valve assembly location, Youngs begins to excavate to install the valve assembly.

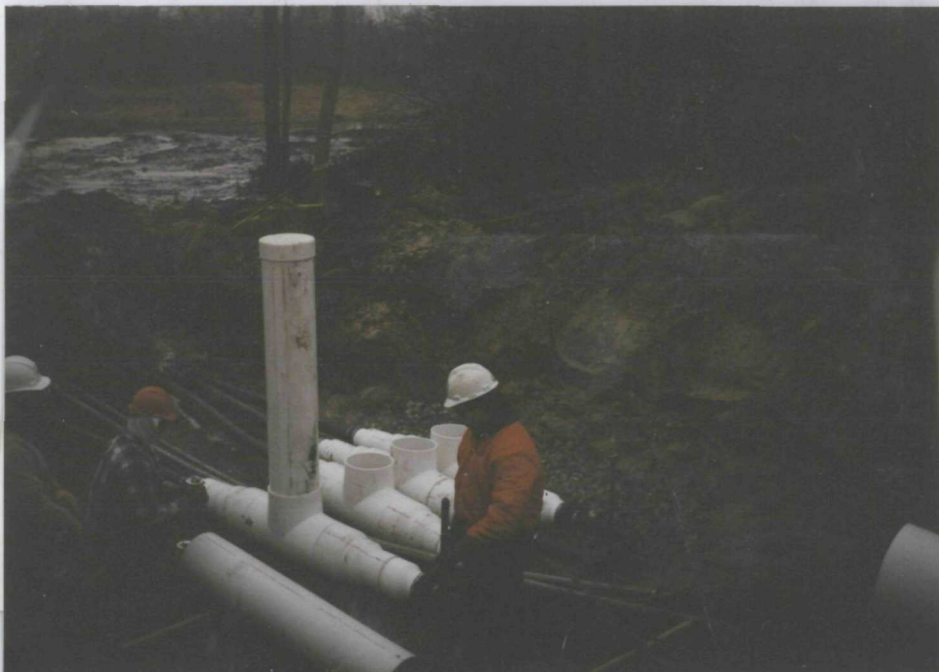
Site: American Chemical Services, Inc. RD/ERA
 Proj. #: 71670.600
 Roll: 3
 Date: 03-13-97
 Photographer: Ashok Rupani
 Description: Facing south-west. Youngs hooking up the valves to the effluent discharge pipes.

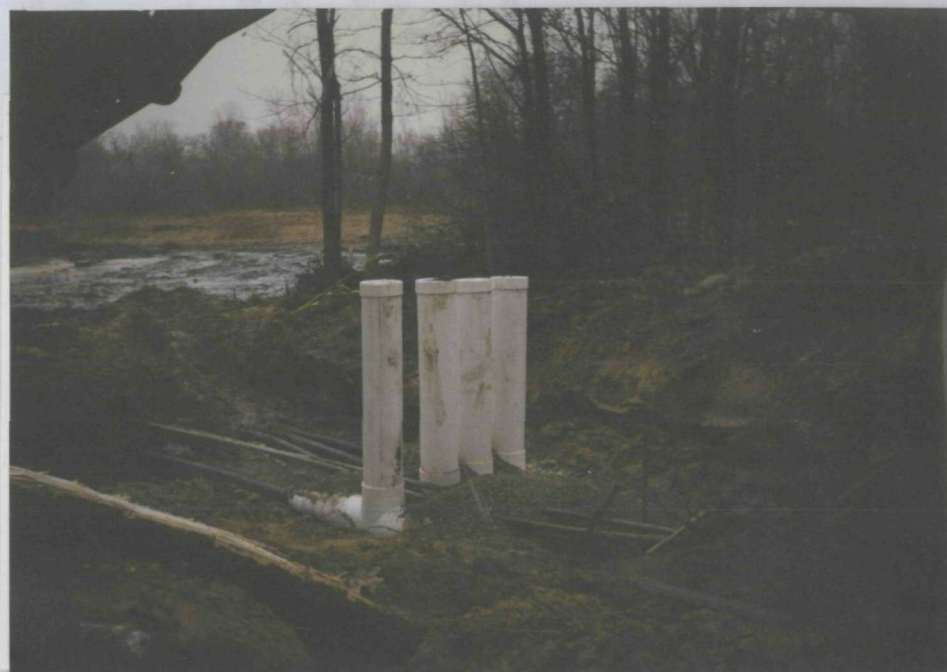
Site: American Chemical Services, Inc. RD/ERA
 Proj. #: 71670.600
 Roll: 3
 Date: 03-13-97
 Photographer: Ashok Rupani
 Description: Facing north-west. Youngs hooking up the valves to the effluent discharge pipes.

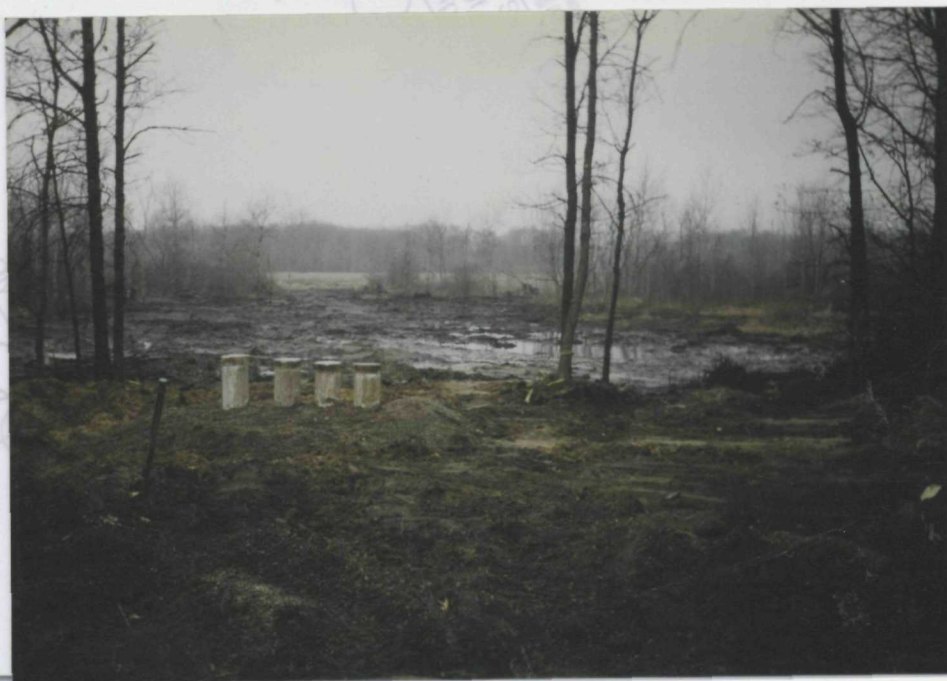
Site: American Chemical Services, Inc. RD/ERA
 Proj. #: 71670.600
 Roll: 3 Photo #: 107
 Date: 03-13-97 Time: 1550
 Photographer: Ashok Rupani
 Description: Facing north-west. Youngs installing the valve assembly.

Site: American Chemical Services, Inc. RD/ERA
 Proj. #: 71670.600
 Roll: 3 Photo #: 108
 Date: 03-13-97 Time: 1550
 Photographer: Ashok Rupani
 Description: Facing north-west. Youngs installing the valve assembly.

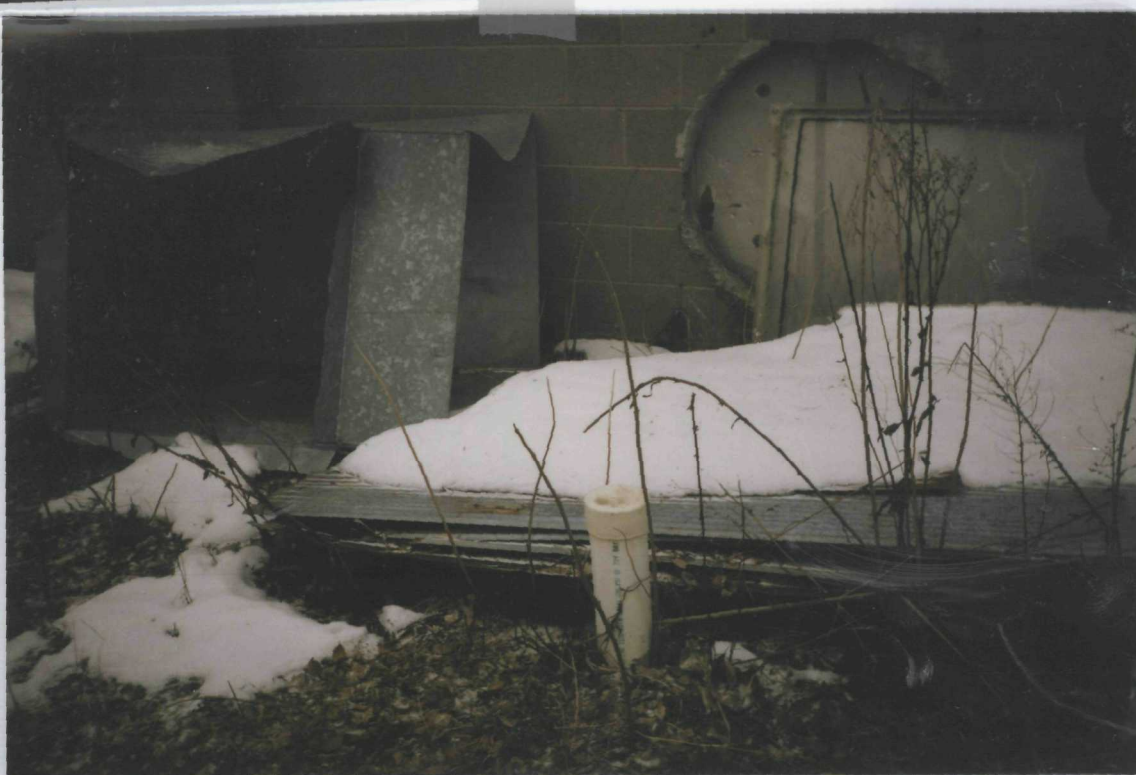
Description: Facing south-west. Youngs completes the valve assembly installation. The excavation was backfilled with native soils and gravel.

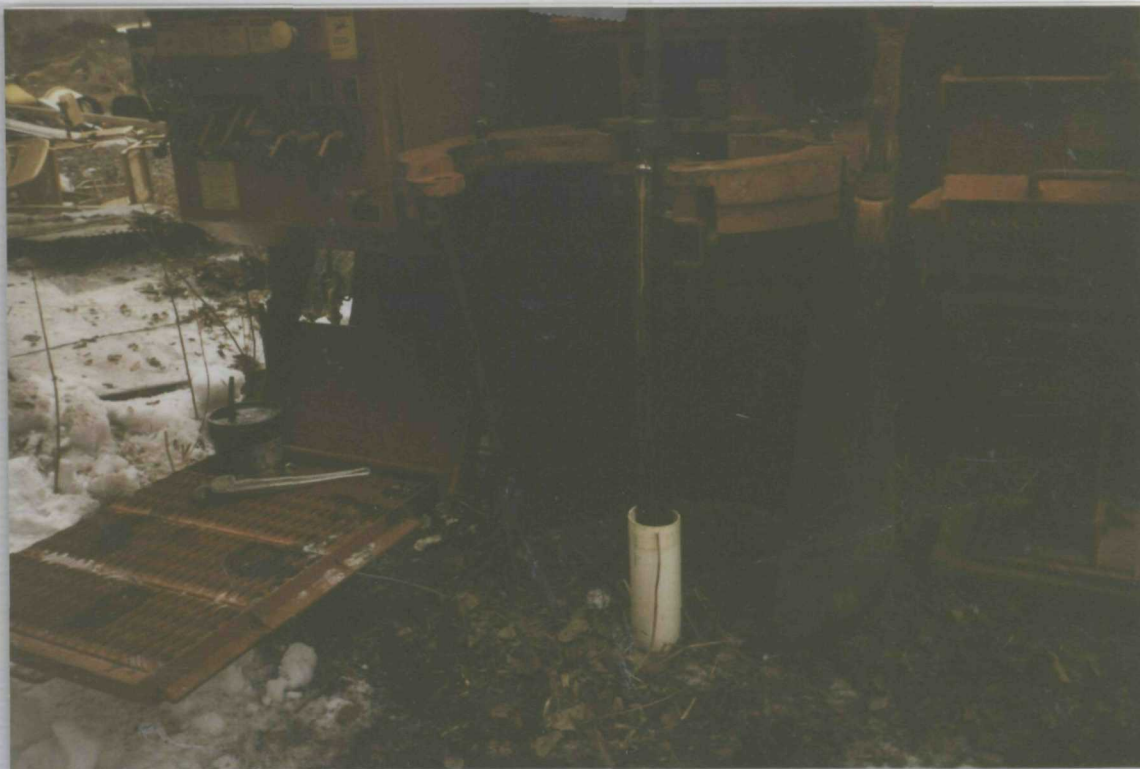
Description: Facing south-east. Montgomery-Watson encountered a production well just a few feet north of the Kapica-Pazmey building. This well was designated as K-P Well.

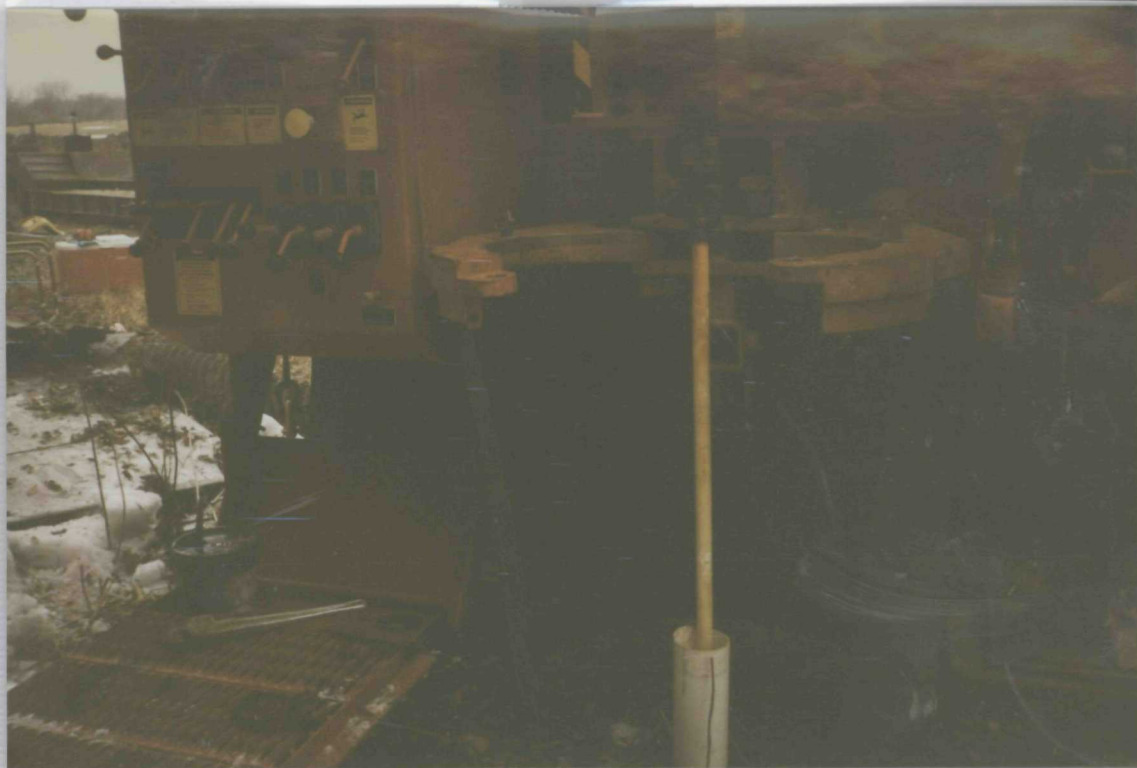
The abandonment activities began by first pulling out the discharge piping from the well. The discharge piping consisted of an inflow and an outflow pipe connected to a PVC header. The water level was measured at 28.2 feet bgs and total depth of the well was measured at 76.04 feet bgs. The measurements indicated that the well was screened in the upper zone of the lower aquifer. Montgomery Watson personnel collected a representative sample for volatile organic compound (VOC) analysis using a stainless steel bailer as opposed to a disposable bailer indicated in the SOP. The disposable bailer could not go down more than couple of feet below water table because the well casing appeared to be at an angle. A water sample at this location would not

Site: American Chemical Services, Inc. RD/ERA
Proj. #: 71670.600
Roll: 1 Photo #: 112
Date: 02-07-97 Time: 1305
Photographer: Ashok Rupani
Description: Facing west. The pumping system in the K-P Well consisted of an inflow and an outflow pipe attached to a PVC header.
